Lessons to be learned

Near casualty during inspection of cargo oil tanks

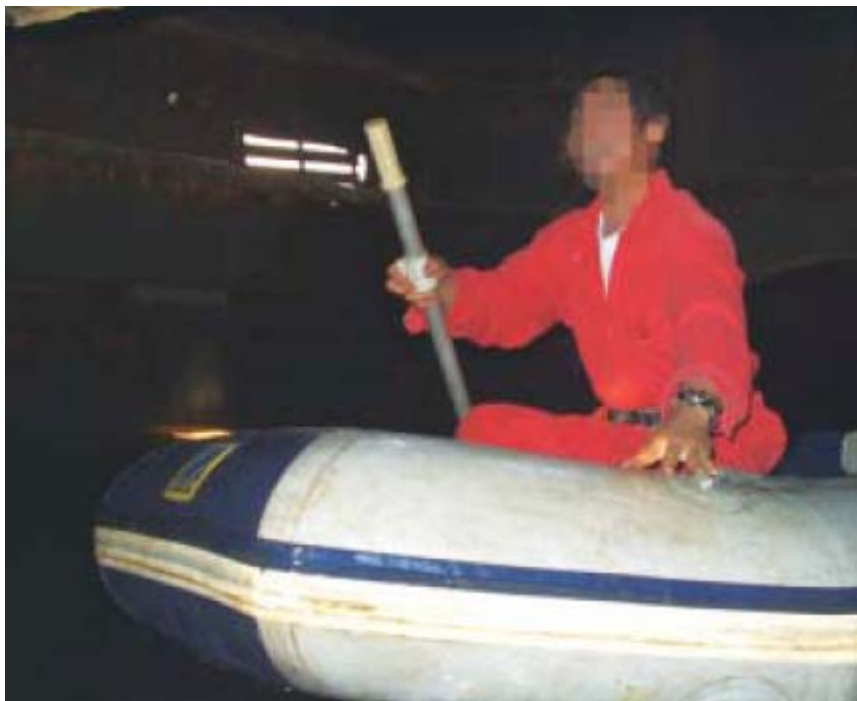
Rafting in cargo tank.

The raft was arranged the next day but as the inspectors were about to start paddling around in the tank, they sensed the smell of gas and had to rush up the ladder and on to the deck. One person became half unconscious and could not stand upright. However, he rapidly recovered and then explained that when he entered the boat to attach the paddles, he suddenly felt a sweet taste in his mouth and became dizzy.

The gas content was most probably caused by cargo residue in the cargo pumps and cargo lines, since these were used during ballasting.

A thin film was visible on the water surface inside tank and there was a slight smell, even at the hatch access level. It is believed that moving of the raft/paddles caused gas to evaporate more quickly from the film on the water surface in the tank, causing the change in the inspection conditions after they started to use the raft.

- Always adhere to required procedures for safe entry of enclosed spaces!
- When conditions for entry are changed, the work permit previously issued is no longer valid and a new permit is to be issued. The new permit is to include proper testing of the tank atmosphere, ventilation and so forth.
