Lessons to be learned

Deliberate grounding due to shift of liquefied cargo

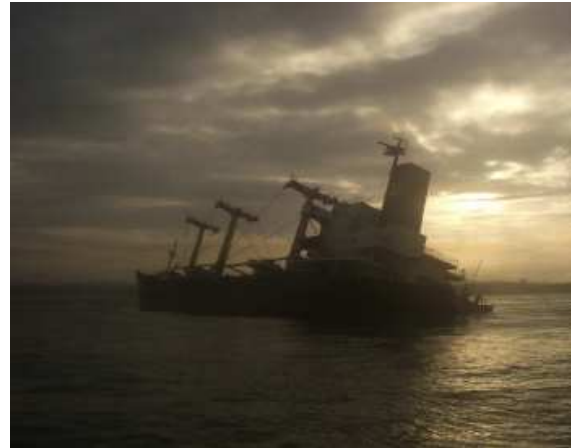
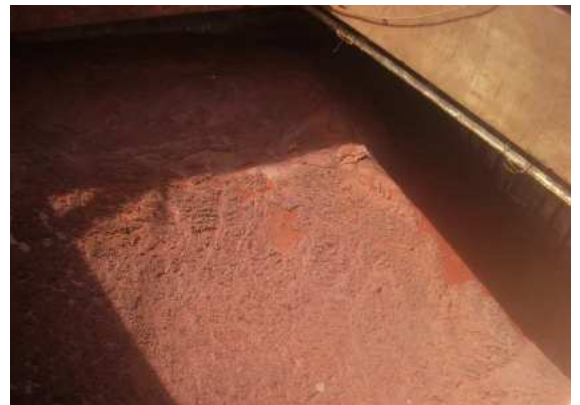
The vessel loaded 20000 MT iron ore fines in New Mangalore, India. The ship departed and only a few nautical miles outside the port the vessel started to develop a list. The list continued to increase and the Captain decided intentionally to run the ship aground intentionally to avoid capsizing.

The cargo is stored without protection and often taken out of the mines with substantial moisture. Due to rain the wetness of the cargo increases. These types of cargo are described in the BC Code as Group A cargoes. A cargo in Group A shall be tested and given a transportable moisture limit (TML) certificate. The following are some of the causes of this grounding

- Either the TML certificates nor the certificates of moisture content were presented or checked
- The cargo was not properly tested prior to loading and during loading
- The high moisture content combined with vibrations of the main engine cause the cargo to liquefy
- The liquefied cargo started to shift shortly after departure
- Due to the list the cargo continued to shift and the list increased even more
- To protect the ship from capsizing the Captain grounded the ship about 3 nm outside the port of loading

- Every cargo that contains moisture and at least some fines and small particles should be queried prior to loading, The BC Code certification requirements apply to all cargoes which may liquefy regardless of whether or not the cargo is specifically identified as posing a liquefaction risk. Never assume there is no risk of liquefaction simply because a cargo is not identified as 'Group A' in the BC Code

- When considering the carriage of Group A cargoes and other cargoes that risk liquefying owners should seek from charterers assurance that the certificates of moisture content and TML will be made available prior to shipment

- If these certificates are not available at the load port, then the Captain should consider refusing the cargo and immediately notify owners, who in turn should contact the Club for advice

- Any certificates provided should be checked to ensure that they are from a reliable source. These certificates may be issued by the mining company and are therefore subject to risk of incorrectness

- Where possible, ship's staff should closely examine the condition of the cargo before it is loaded, and should closely monitor its condition throughout loading and whenever it is brought alongside the vessel. Even when the cargo appears to be dry, it may still contain moisture in excess of TML, but if it appears wet, or is stored in open conditions in rainy weather, then experience indicates that moisture content may well be above TML
