January 2011 Issue 10-2

Responsibilities that Accompany On Deck Cargoes

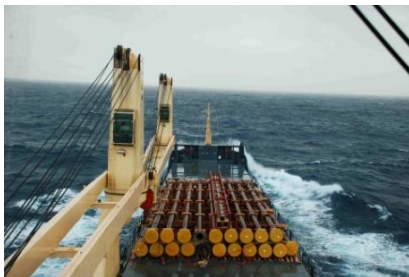
Pipes stowed on deck

- The cradles may not have been of a sufficient length
- The cradles were not secured to each other to create a block stow
- The dunnaging of the pipes, resting in each cradle, were not sufficiently blocked to avoid any movement
- The heavy piece on top of the pipes was not sufficiently lashed and secured
- The pipes and cradles were not adequately lashed and secured to the vessel rather than to each other.

- Since the head charter party placed the loading and stowage of the cargo under the supervision and responsibility of the master, and the shipment in question was intended for on deck stowage, it should have been assumed that the cargo would be oversized and, probably, high-priced. The owners should have protected themselves by having a surveyor in attendance during the loading and stowage of the cargo. It could then be argued that the stowage, which was performed by the charterer and/or the shipper, would have been different and the loss would have been avoided.

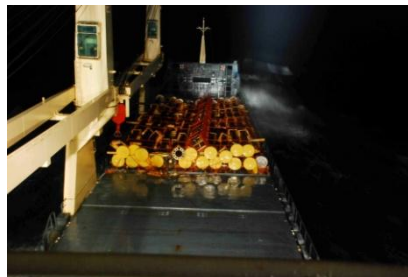
Pipes breaking stow

As a result, when the vessel was affected by the heavy weather during her voyage, the pipes were allowed to move within the cradles and the cradles were allowed to shift. This quickly evolved into the failure of the lashings and the cargo falling overboard.
