Lessons to be learned

Deliberate grounding due to shift of liquefied cargo

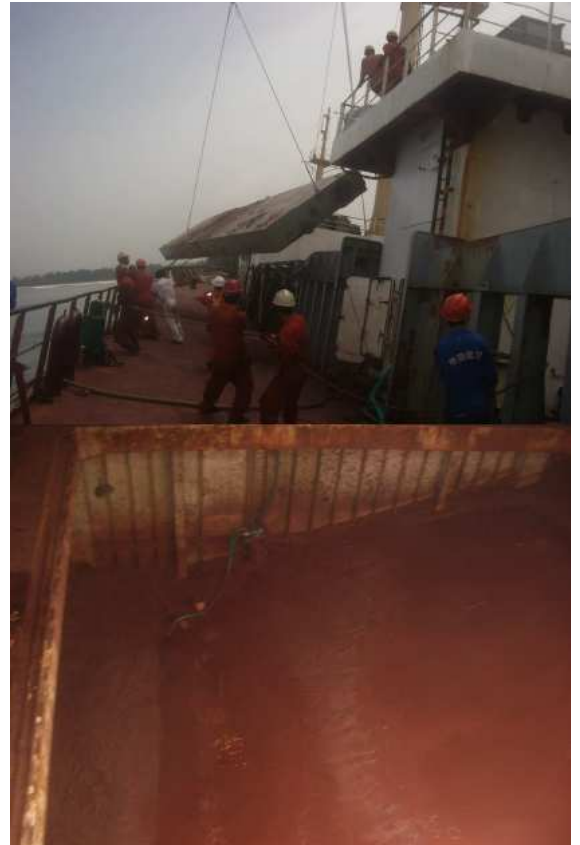
The vessel loaded 20000 MT iron ore fines in New Mangalore, India. The ship departed and only a few nautical miles outside the port the vessel started to develop a list. The list continued to increase and the Captain decided intentionally to run the ship aground intentionally to avoid capsizing.

- Either the TML certificates nor the certificates of moisture content were presented or checked
- The cargo was not properly tested prior to loading and during loading
- The high moisture content combined with vibrations of the main engine cause the cargo to liquefy
- The liquefied cargo started to shift shortly after departure
- Due to the list the cargo continued to shift and the list increased even more
- To protect the ship from capsizing the Captain grounded the ship about 3 nm outside the port of loading

- Where possible, ship's staff should closely examine the condition of the cargo before it is loaded, and should closely monitor its condition throughout loading and whenever it is brought alongside the vessel. Even when the cargo appears to be dry, it may still contain moisture in excess of TML, but if it appears wet, or is stored in open conditions in rainy weather, then experience indicates that moisture content may well be above TML

- A negative result from a *can test* described in section 8.3 of the BC Code (i.e. no free moisture or fluid condition is seen) does not necessarily mean that the cargo is safe for shipment. However, a positive result from such test, where moisture is seen, should leave the Captain in no doubt that further testing is required

- In all circumstances shipmasters and owners should closely follow the recommendations contained in the BC Code (latest edition, 2005)
- In the rainy season pre-loading and loading surveys is recommended to be carried out
